## The Warwick Explosion : a Case Study

This material was published in print form as two separate articles, in the *Journal de l'Association des techniciens en prévention incendie du Québec*, Vol.8, No.2, June 1997. Hugh Chicoine Certified Fire and Explosion Investigator, p.13-19. Gaston Brosseau Engineer, p.20-23.

### Executive Summary:

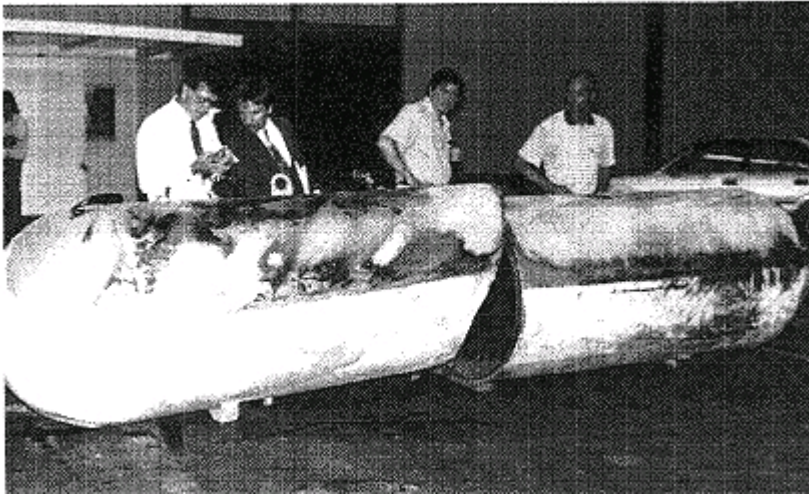
photo 1, courtesy CSST

**photo 1)** traces of smoke: black lines are smoke deposits (these occur only on cold surfaces relative to ambient). They do not all disappear in the course of a fire (Gayet, 1973). The reader may observe that the horizontal black lines are not all at the same level. This may be explained: the level of the liquid in the tank decreased each time the valve operated, venting substantial quantities of

propane.

Smoke deposits on the outer shell (mid-level, right side, photo 1) are material evidence that the tank has been massively enveloped in smoke over time, and was therefore in a current of convection that was just as constant. Moreover, on photograph 1, it can be seen that the upper part of the tank displays an altered area. This altered area, which has no definite geometrical shape, indicates overheating on more than half the length of the tank.

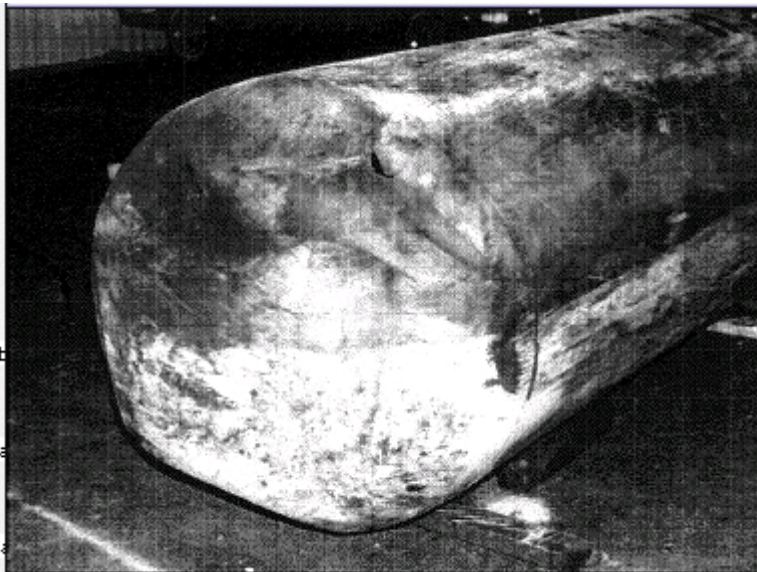
photo 2, courtesy CSST

**photo 2)** alteration of the tank surface on the left side is also visible, but there is no trace of smoke (on colour image, provided on request and without delay). This superficial alteration is due to the radiation of the fire.

Finally, photo2 shows the extremity of the tank which was the most exposed to heat. It displays a hot spot (upper left), apparently oxidised, and is located above the liquid phase of the propane.

As may be seen on the CSST photographs, visible patterns on the tank are such as they were at the moment of the explosion, with the exception of the oxidised sector (the hot spot), which could have been reddish (depicting overheating).
